River Road ILF Project Site
LRB-2019-01207

Prepared by:
Ducks Unlimited New York In-Lieu Fee Program
LRB-2010-00673 (ILFP)

DATE: 30 June 2021

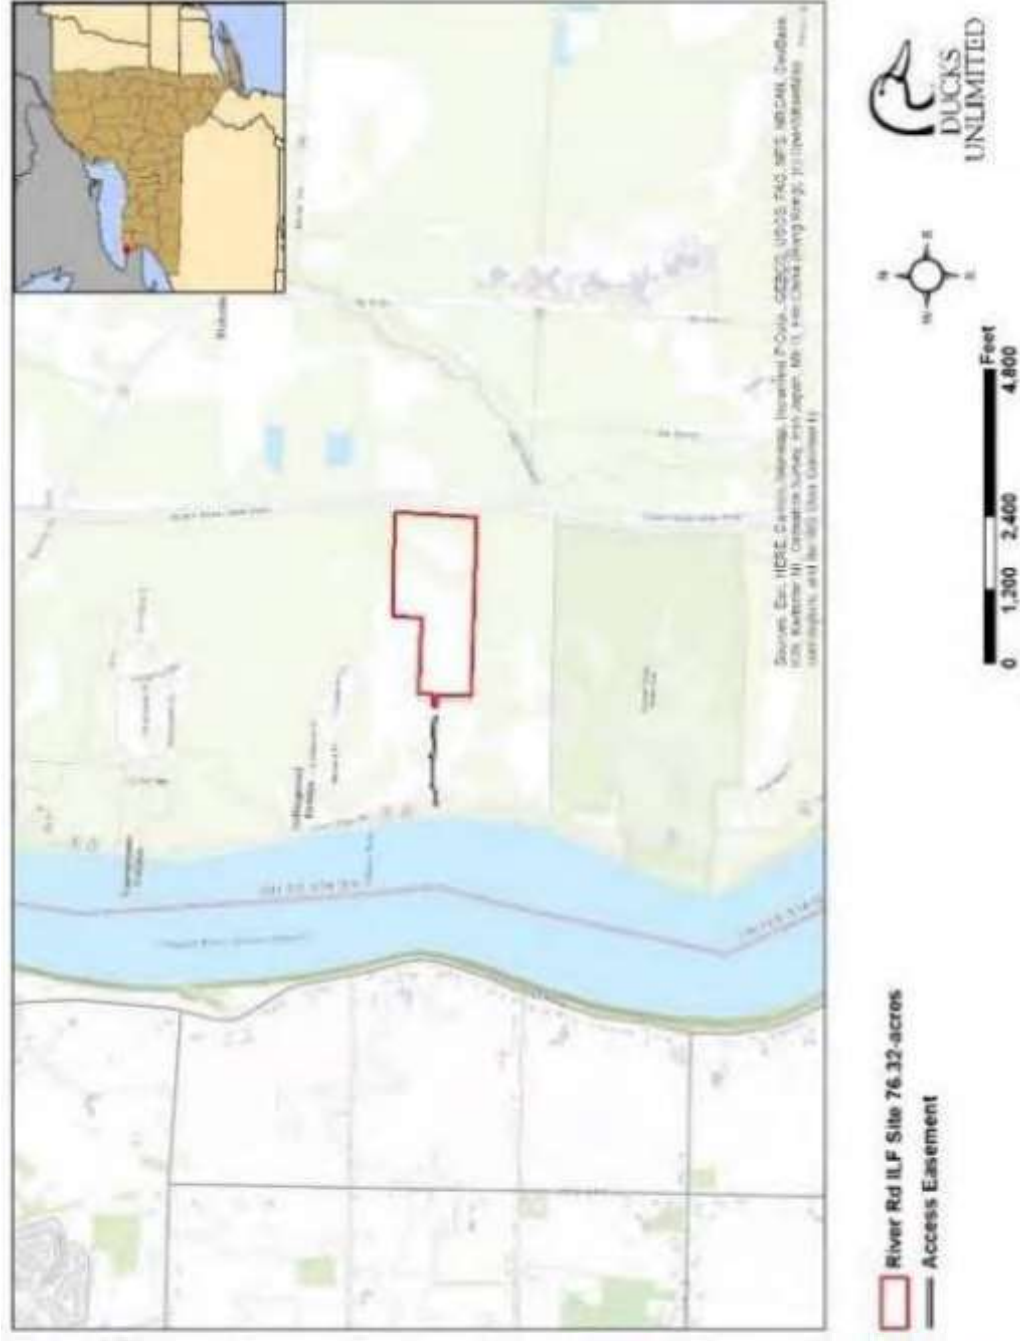
Figure 2 Proposed ILF Site.

The Site is near the Niagara River. Lake Ontario (not shown) lies just over a mile to the north of the site.

The Site is hydrologically connected through a series of shallow ditches through the property to the west to the Niagara River.

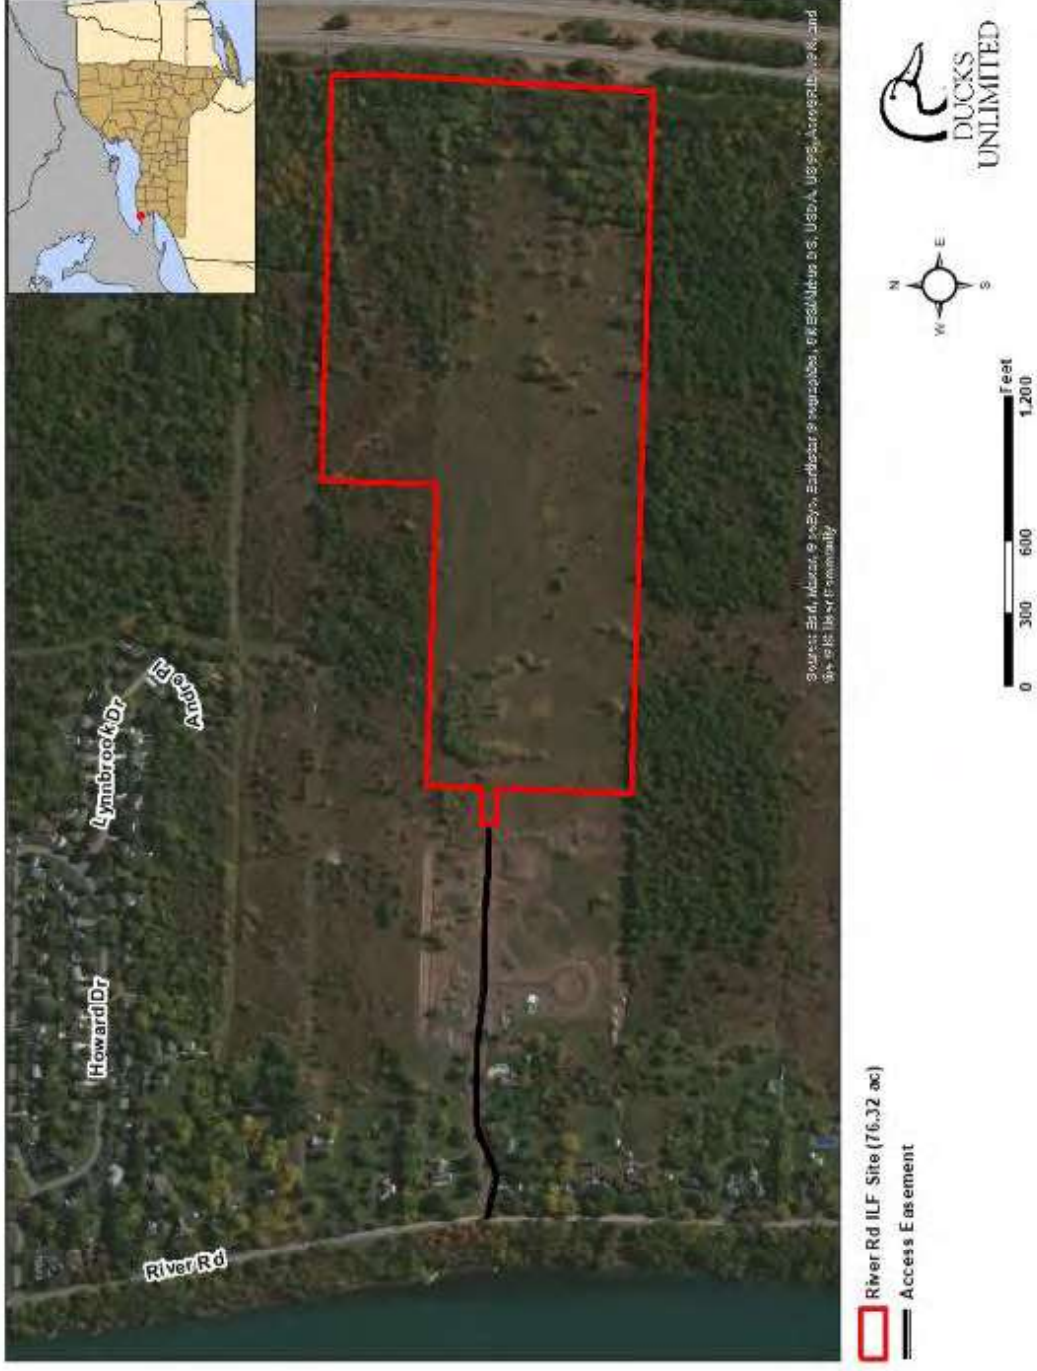
Figure 3 View of the Site.

Wetland America Trust, a wholly owned subsidiary of Ducks Unlimited owns the property. The property is accessed via an easement from the West. The neighboring property is a housing subdivision. Provisions to access the Site were recorded to the deed and took into account a future cul-de-sac where access ties into the existing easement.

The geographic boundaries of the Site correspond to the 76.32-acre area to be placed under a conservation easement (red-line) as depicted in Figure 2, and in Appendix E. The Site lies to the west of the Niagara Scenic Parkway in Porter. The site is accessed on the west side by an access easement from River Road (Figure 3). Private lands, much of which are forested, border the Site to the north and south.

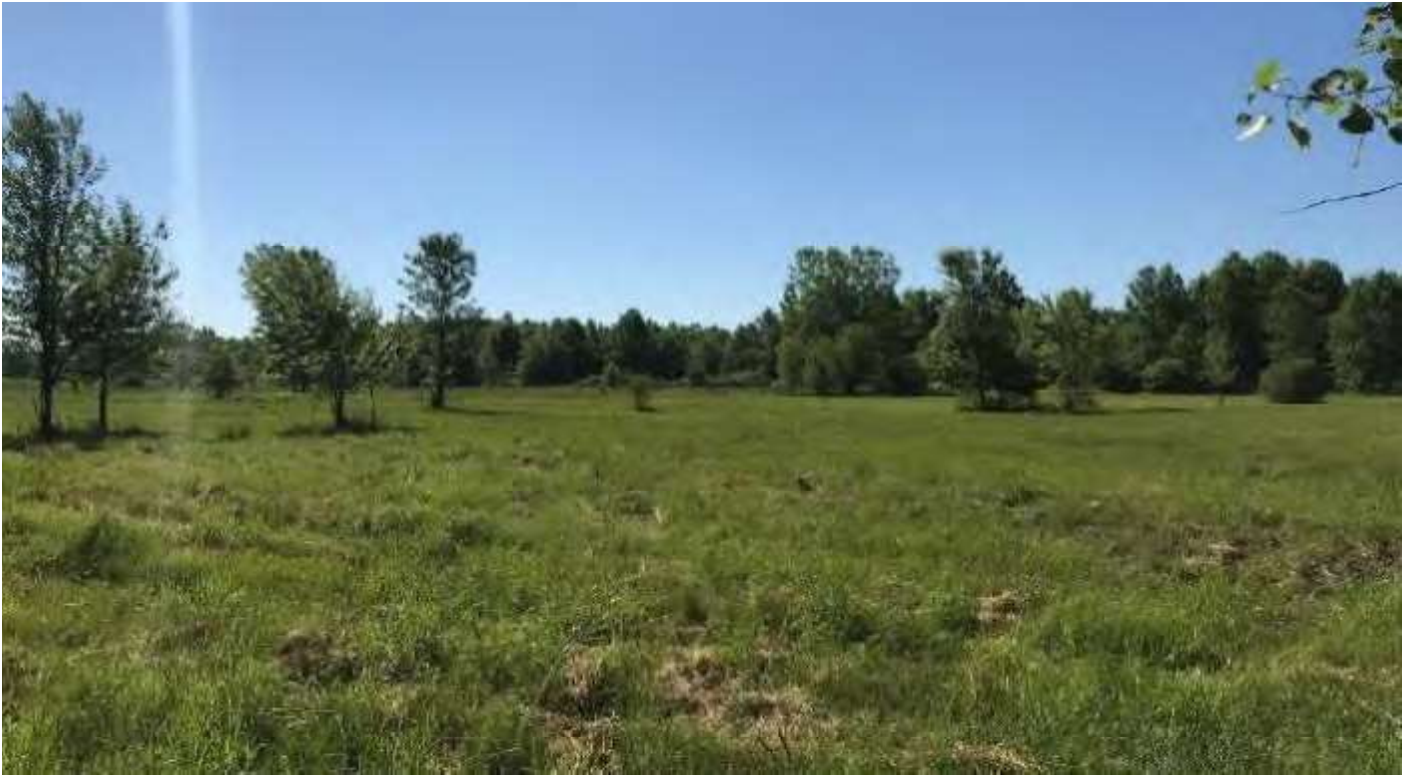
A June 12, 2019 visit occurred in a relatively dry period. This area held standing water earlier in spring and was being utilized by mallards.

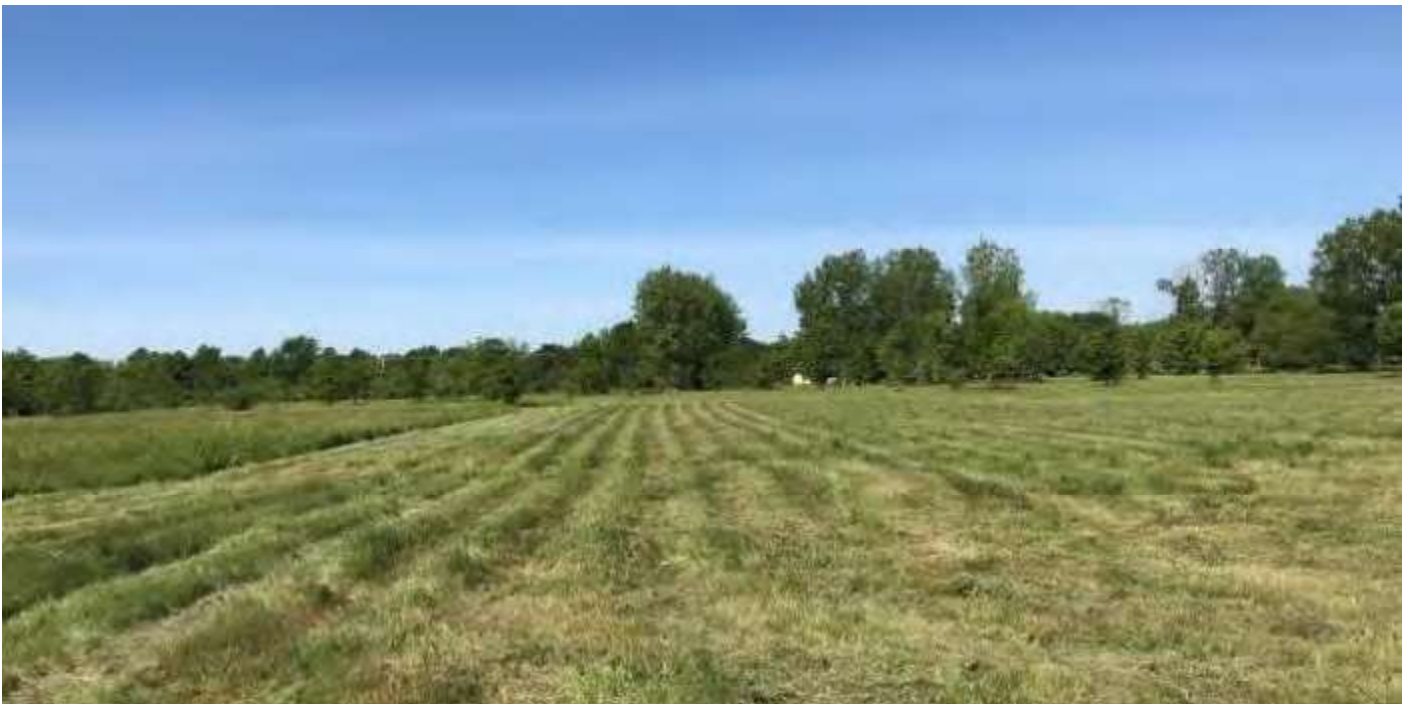
Previous owner has been brush-hogging the property. June 2019.

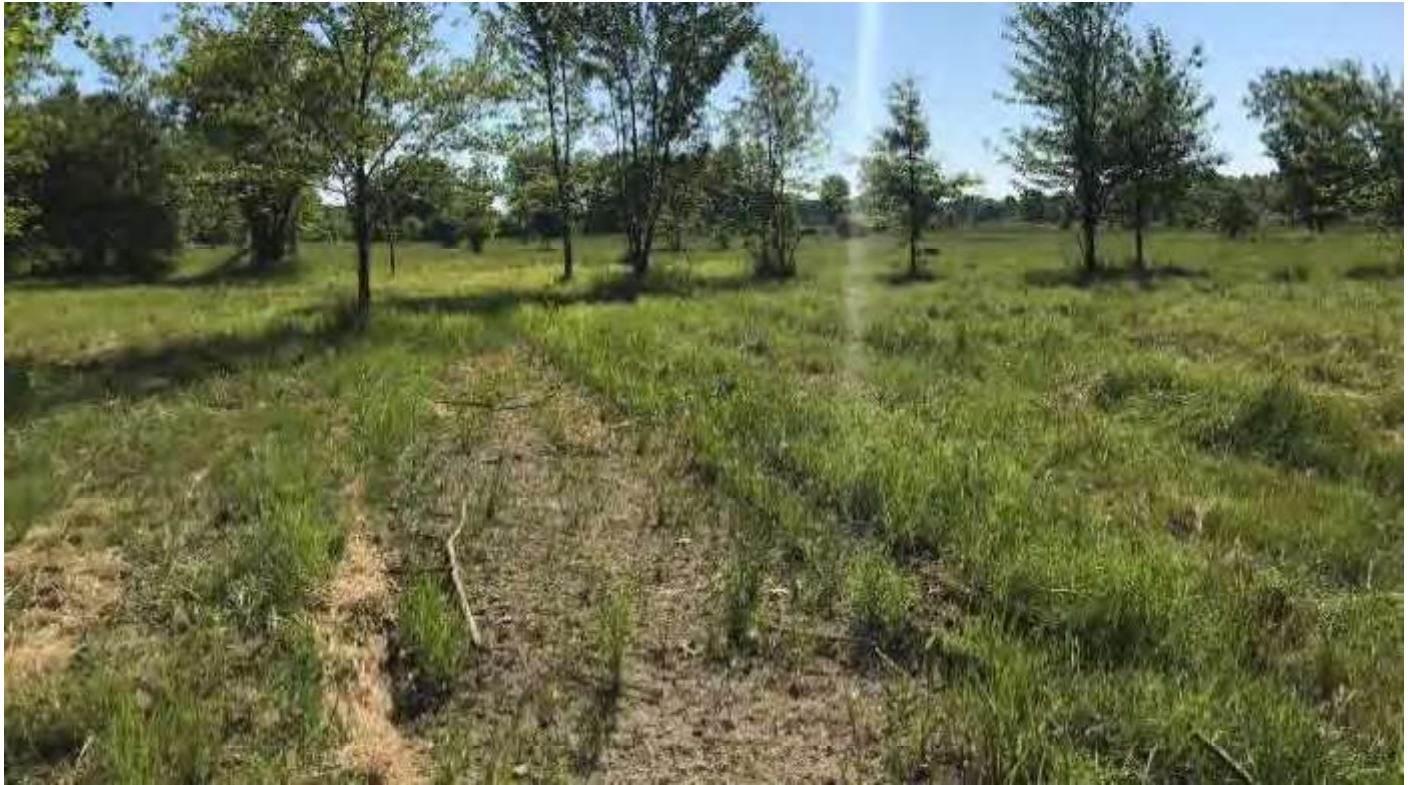
Pockets too wet to brush-hog existed throughout the site.

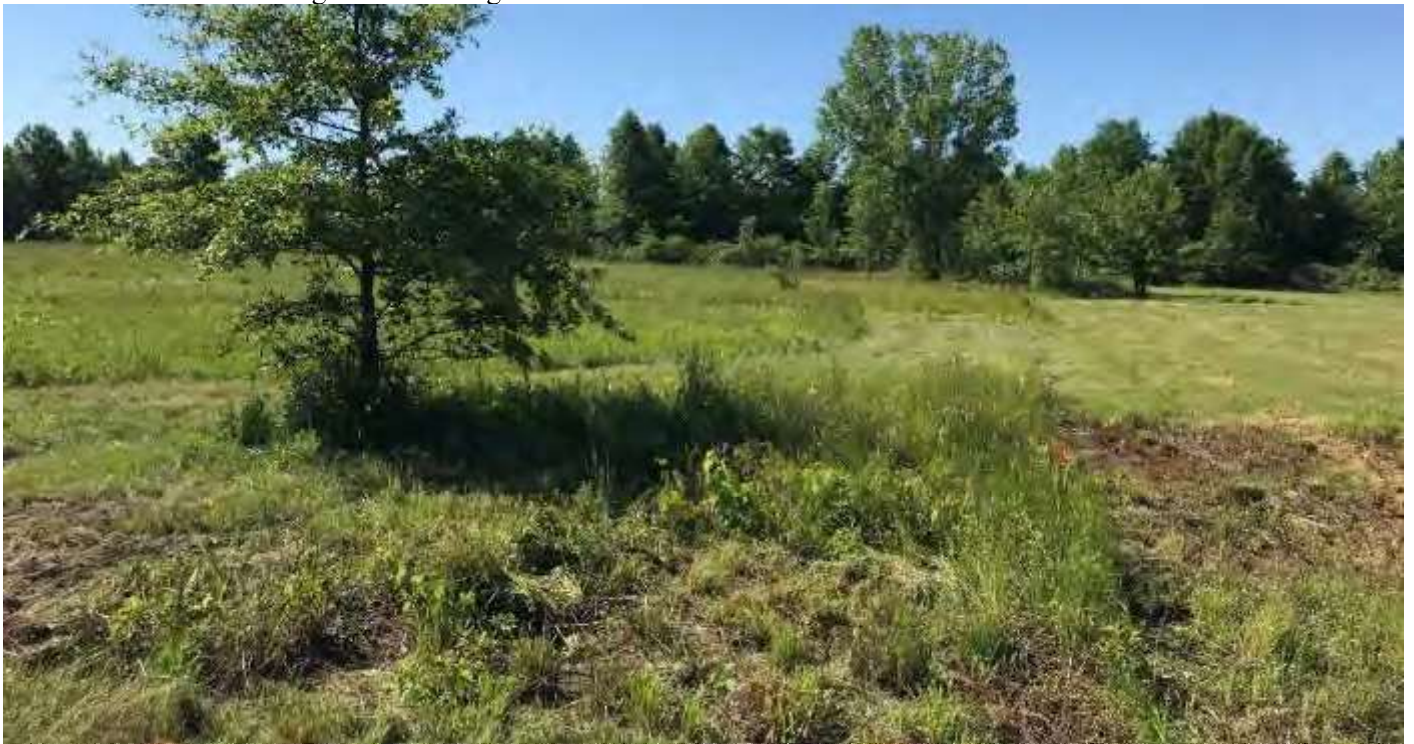
A network of ditches conveying water appear to be prime targets to convey hydrology to constructed wetland basins. Photographed on April 3, 2019.

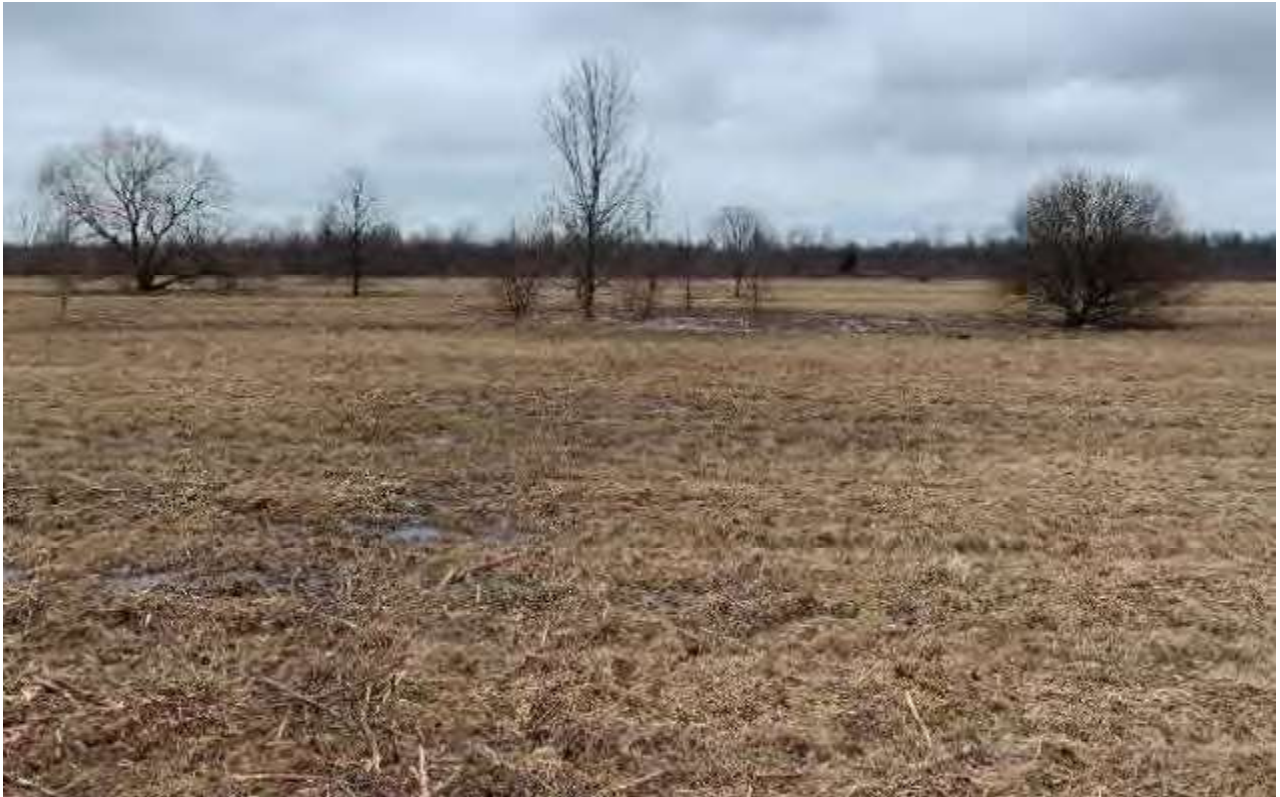
Eastern areas of the property supported facultative plant species, and areas that appeared suitable for basin excavation. Pictured January 2020.

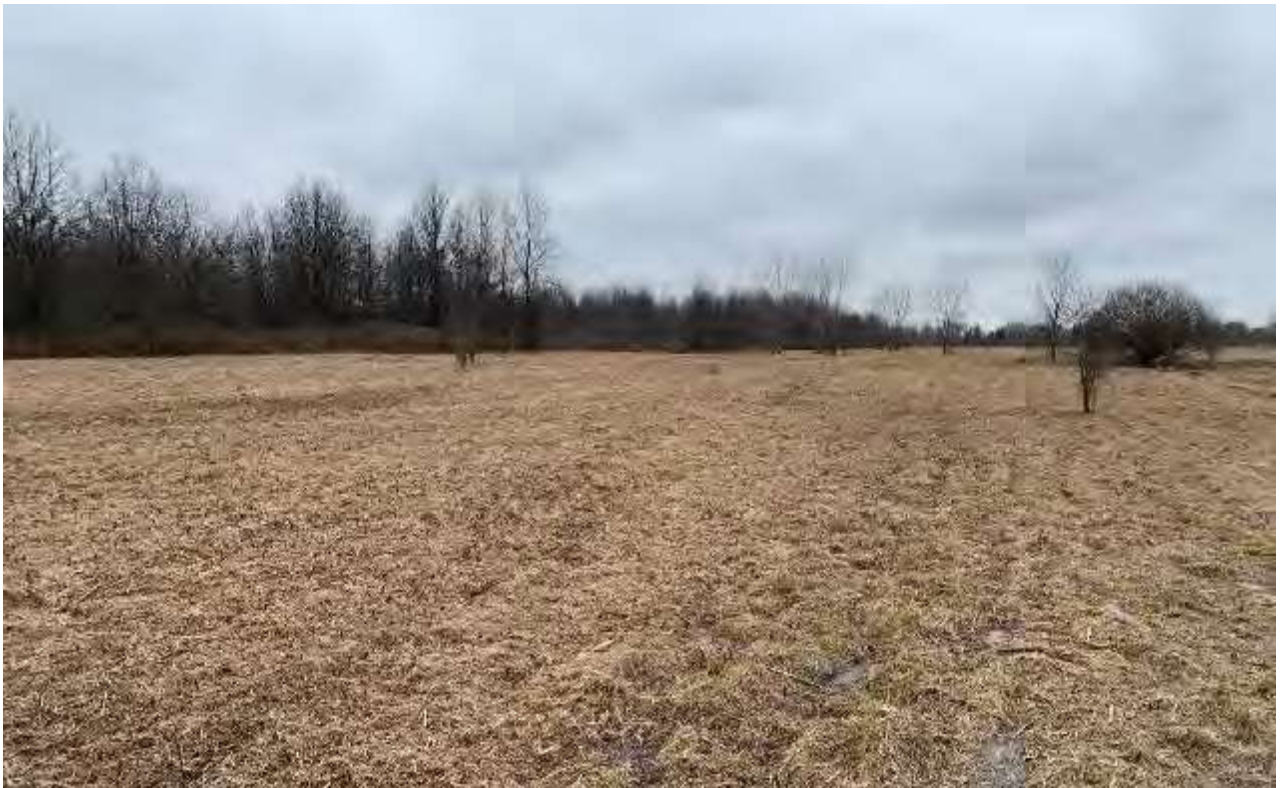
Areas suitable for restoration activities, pictured January 2020.

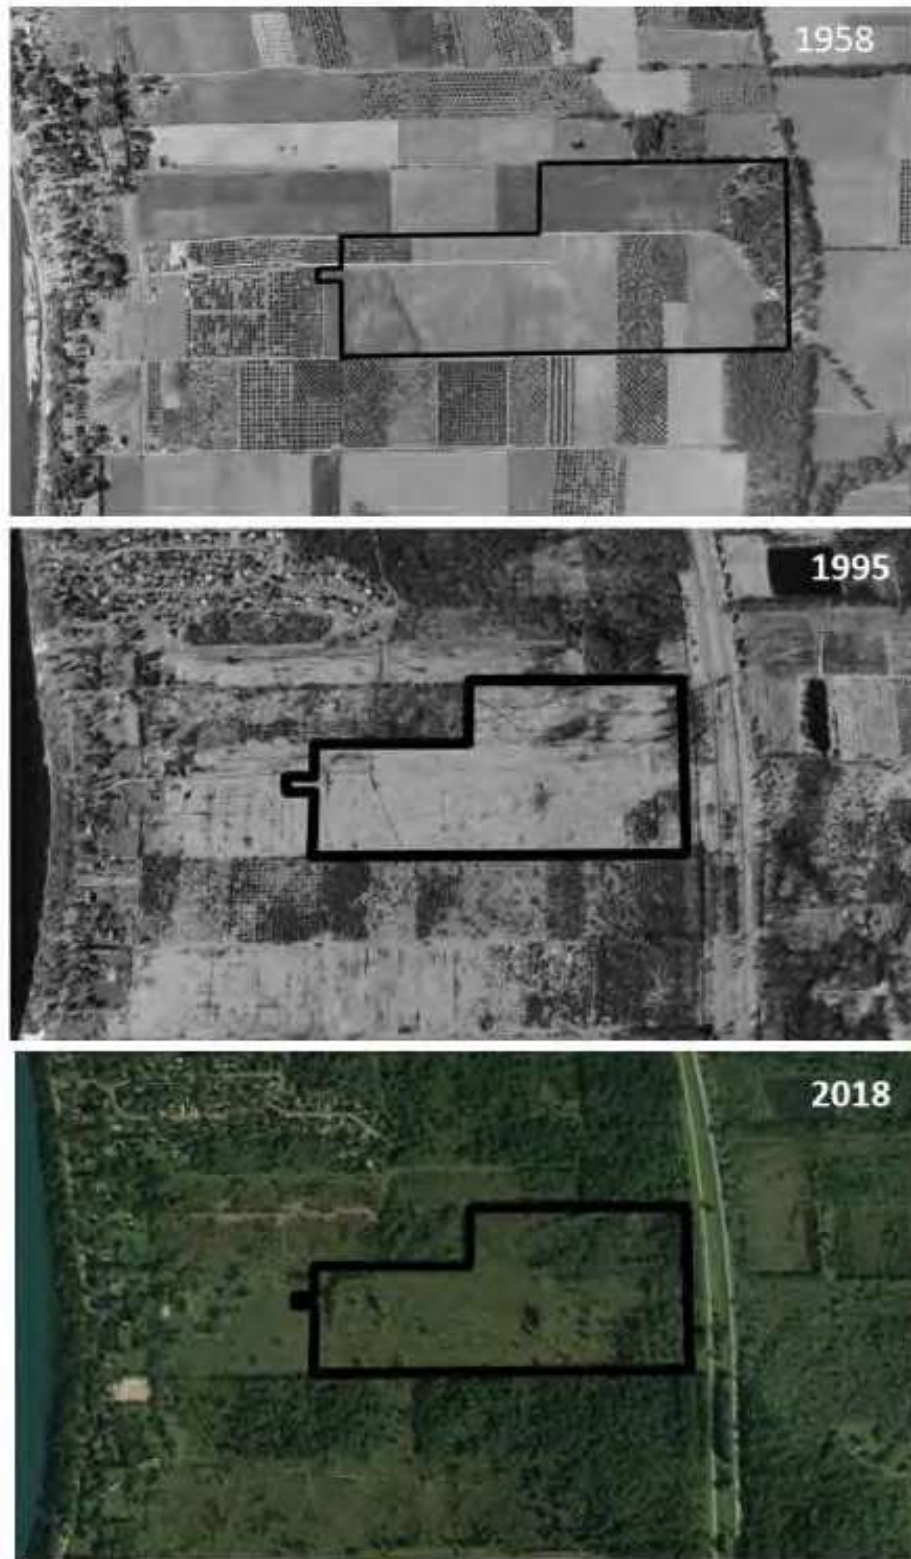
Figure 4 Historical Aerial Photos from River Road.

The property was in agricultural use until the late 1900's. Recent management has included periodic mowing of much of the previous agricultural lands.

The Site has a history of use as agricultural land dating back to at least the 1950's (Figure 4). Vegetation communities were surveyed between May and September of 2020, and are further described in the wetland delineation report in Appendix A. Here we provide a brief summary of the plant communities and provide photographs of current site conditions. The emergent wetlands within the fallow fields are dominated by rough bentgrass (*Agrostis scabra*), meadow foxtail (*Alopecurus pratensis*), fox sedge (*Carex vulpinoidea*), gray dogwood (*Cornus racemosa*), common goldentop (*Euthamia graminifolia*), green ash (*Fraxinus pennsylvanica*), soft rush (*Juncus effusus*), sensitive fern (*Onoclea sensibilis*), crooked-stemmed aster (*Symphyotrichum prenanthoides*), and riverbank grape (*Vitis riparia*). Wetlands C, E, and G also contain small stands of common reed (*Phragmites australis*). Upland areas within the fields are dominated by rough bentgrass (*Agrostis scabra*), spotted knapweed (*Centaurea stoebe*), Kentucky blue grass (*Poa pratensis*), Canada goldenrod (*Solidago canadensis*), and riverbank grape (*Vitis riparia*). The forested wetlands are dominated by eastern cottonwood (*Populus deltoides*), pin oak (*Quercus palustris*), black willow (*Salix nigra*), and American elm (*Ulmus americana*), with meadow foxtail (*Alopecurus pratensis*), gray dogwood (*Cornus racemosa*), teal lovegrass (*Eragrostis hypnoides*), green ash (*Fraxinus pennsylvanica*), and reed canary grass (*Phalaris arundinacea*) in the understory.

There are no structures on the property. From a review of aerial photography dating back to 1958, fields within the Site were continuously maintained for agricultural production through the 1970's. 1958-2018 aerial photos are shown in Figure 4. The property was mowed in 2019. On-site reviews in April and June 2018, July 2019, January 2020, and May through September 2020 provided evidence of previous hydrological modifications, including ditching. The Site appears to have historically supported more extensive wetlands prior to drainage and tillage activities. There are no known hazardous material sites located on or within the vicinity of the Site.

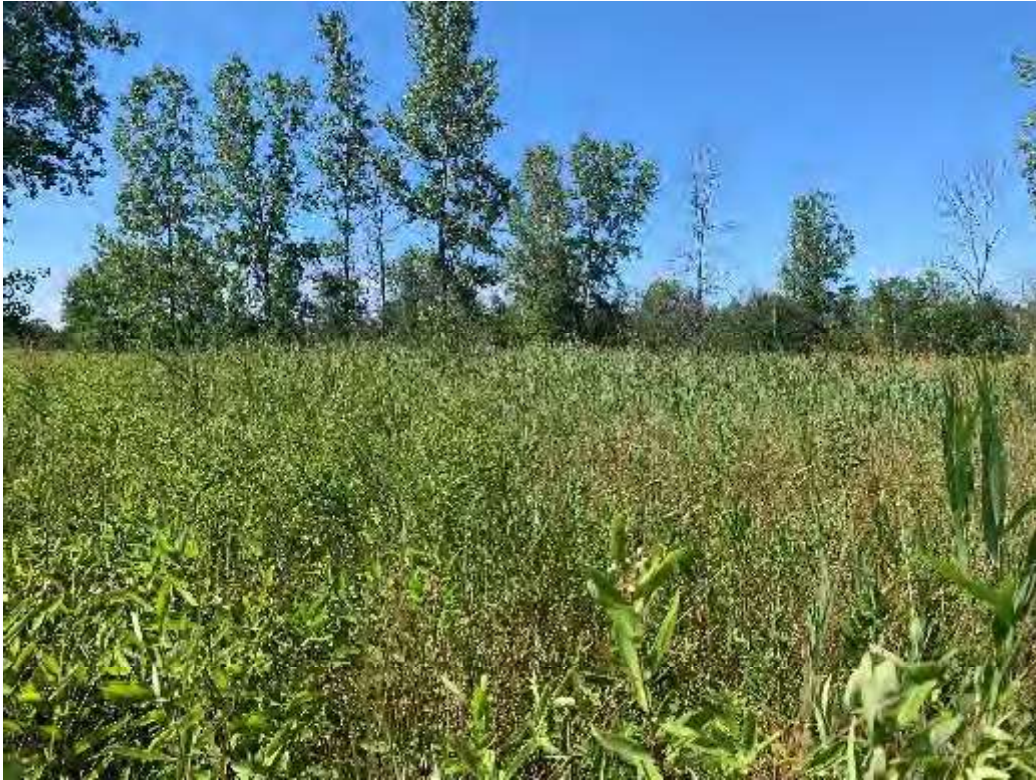
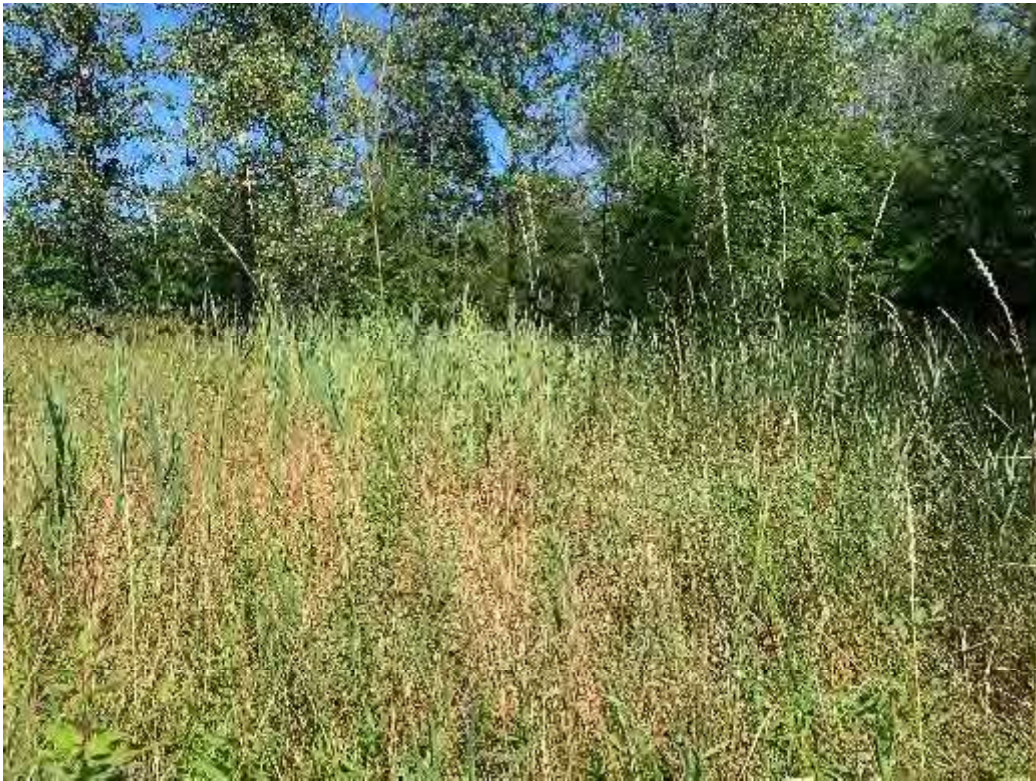
Stands of Phragmites at the eastern end of the fallow field.

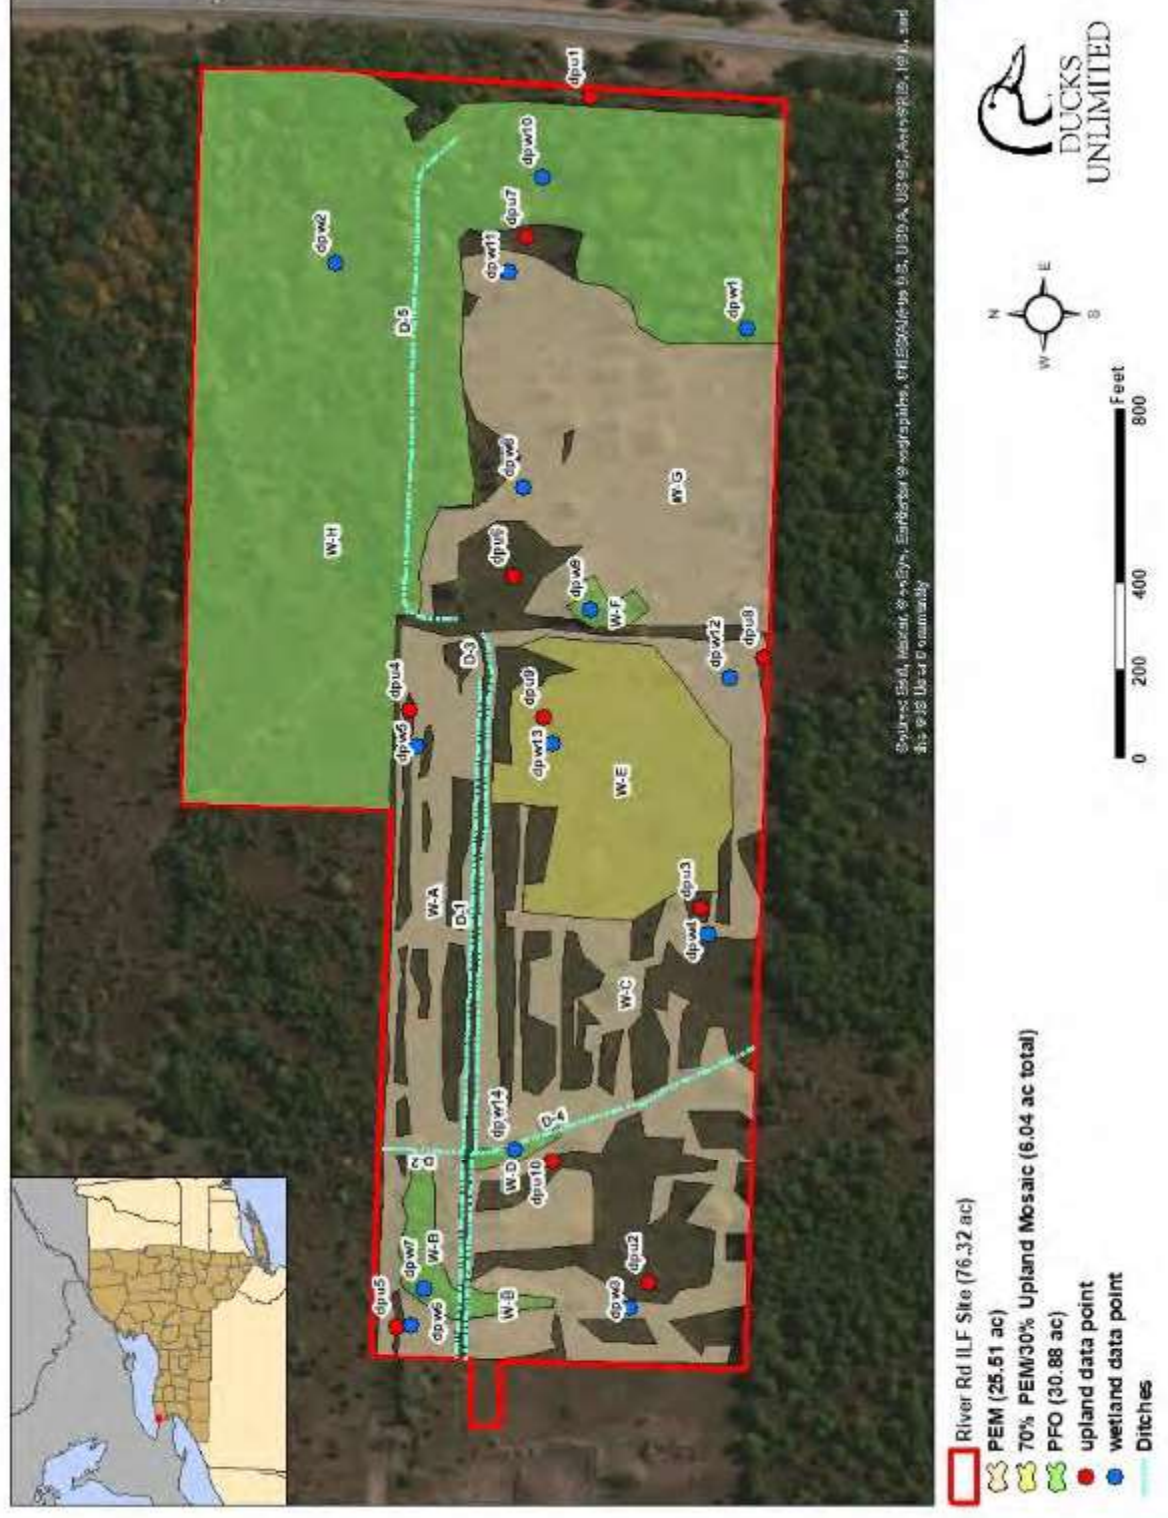
Wetland Delineation Map and Datasheets:

Normal circumstances were present at the time of data collection. The most prevalent type of wetland delineated at the Mitigation Site was palustrine emergent (PEM, 30.31 acres) wetlands. The wetland component of the 6.04-acre PEM/upland mosaic (Wetland E) is 70%, equivalent to 4.23 acres of PEM.

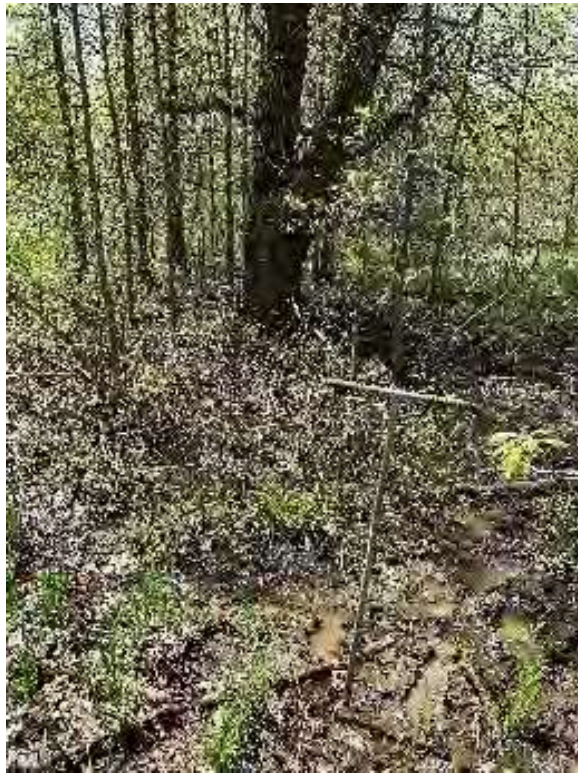
DPW1. This portion of forested Wetland H was dominated by pin oak (*Quercus palustris*), with gray dogwood (*Cornus racemosa*) and reed canary grass (*Phalaris arundinacea*) in the understory. Primary hydrology indicators included surface water, a high-water table, saturation, sparsely vegetated concave surface, water-stained leaves, and oxidized rhizospheres on living roots. Depleted below dark surface and redox dark surface were the hydric soil indicators. Photo taken May 22, 2020.

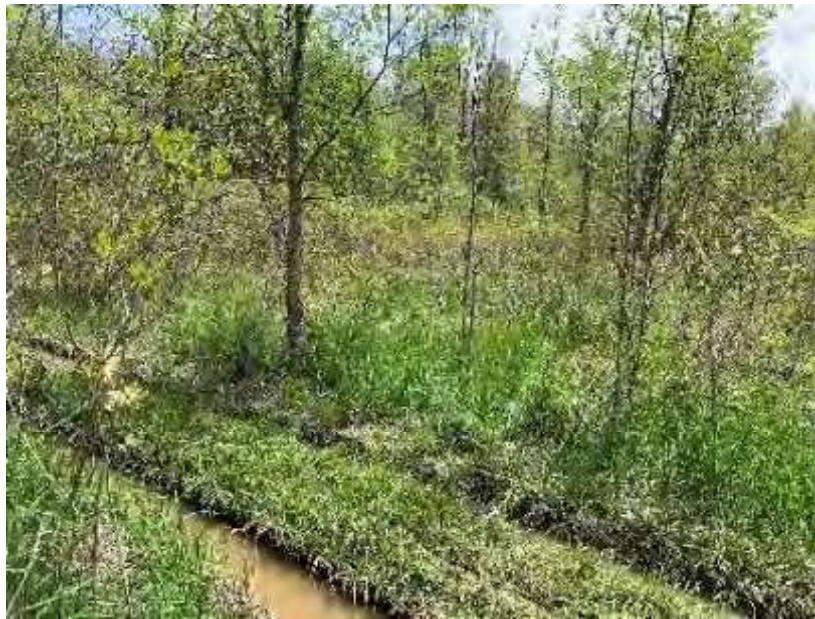
DPW2. This portion of forested Wetland H was dominated by American elm (*Ulmus americana*), with gray dogwood (*Cornus racemosa*) and meadow foxtail (*Alopecurus pratensis*) in the understory. Primary hydrology indicators included saturation and oxidized rhizospheres on living roots. A redox dark surface was the hydric soil indicator. Photo taken May 22, 2020.

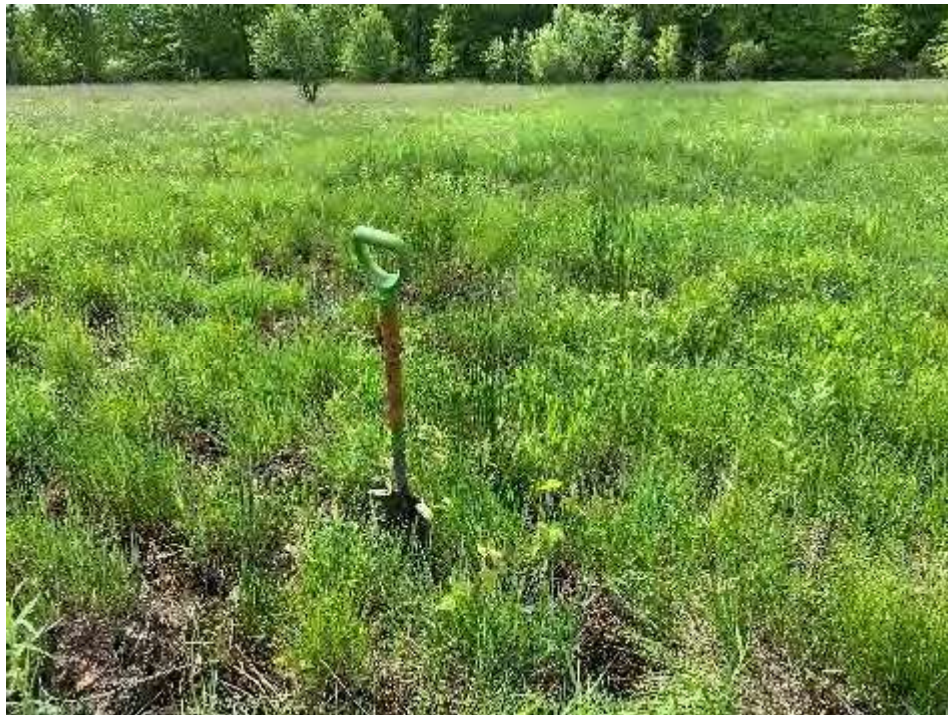
DPW3. This portion of emergent Wetland C was dominated by meadow foxtail (*Alopecurus pratensis*). Primary hydrology indicators included surface water, a high-water table, saturation, and oxidized rhizospheres on living roots. A depleted matrix was the hydric soil indicator. Photo taken June 2, 2020.

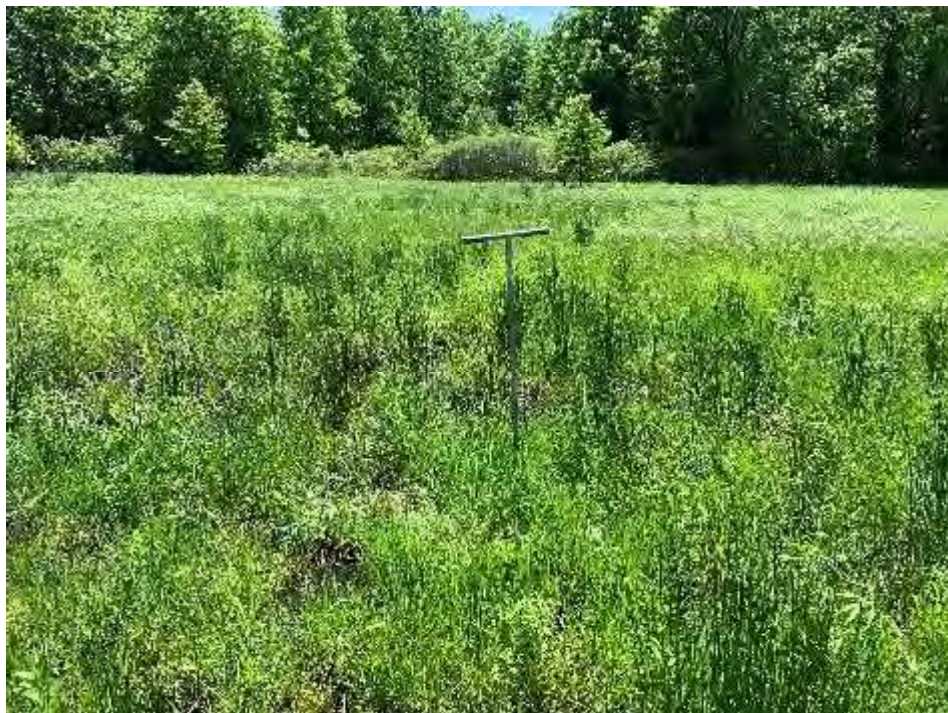
DPW4. This portion of emergent Wetland C was dominated by rough bentgrass (*Agrostis scabra*) and soft rush (*Juncus effusus*). Primary hydrology indicators included surface water, a high-water table, and saturation. A depleted matrix was the hydric soil indicator. Photo taken June 4, 2020.

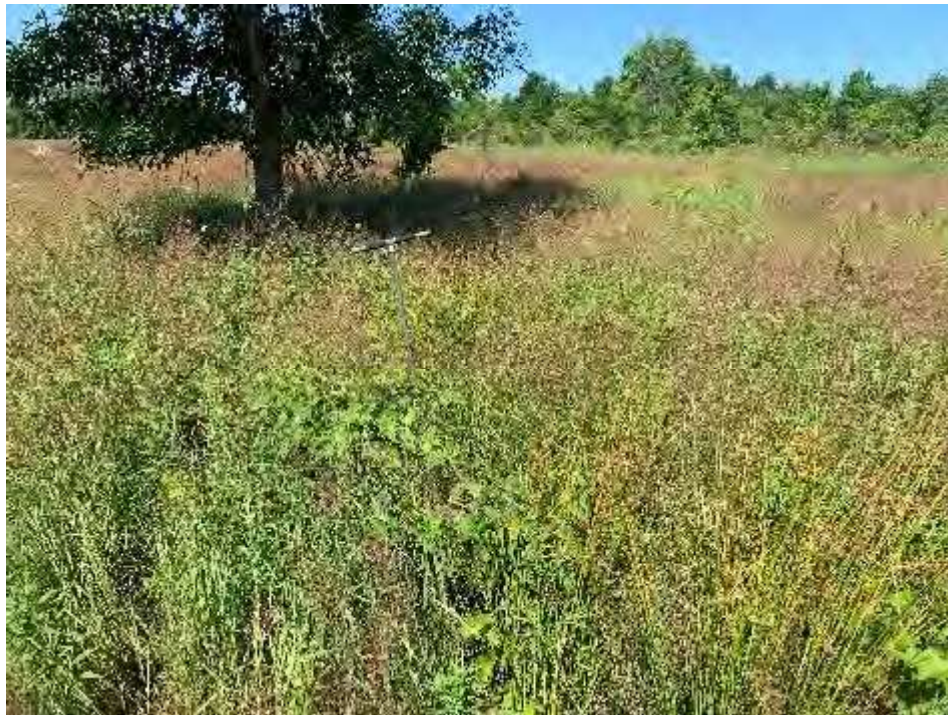
DPW5. This portion of emergent Wetland A was dominated by green ash (*Fraxinus pennsylvanica*), rough bentgrass (*Agrostis scabra*), and riverbank grape (*Vitis riparia*). The primary hydrology indicator was oxidized rhizospheres on living roots. Depleted below dark surface, a depleted matrix, and redox dark surface were the hydric soil indicators. Photo taken July 17, 2020.

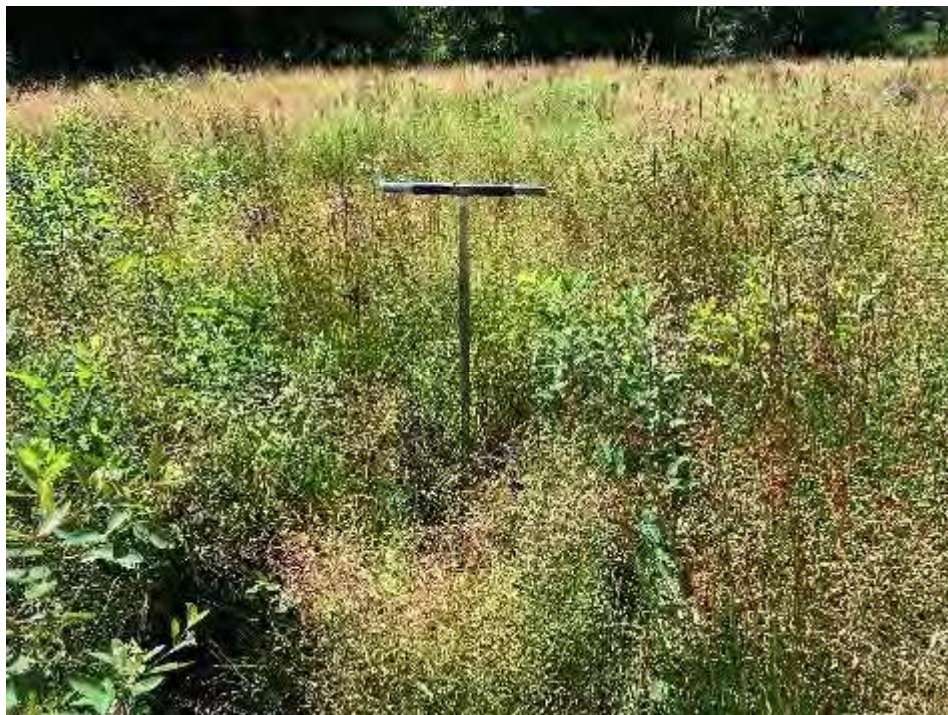
DPW6. This portion of emergent Wetland A was dominated by rough bentgrass (*Agrostis scabra*) and soft rush (*Juncus effusus*). The primary hydrology indicator was oxidized rhizospheres on living roots. Depleted below dark surface and a depleted matrix were the hydric soil indicators. Photo taken July 28, 2020.

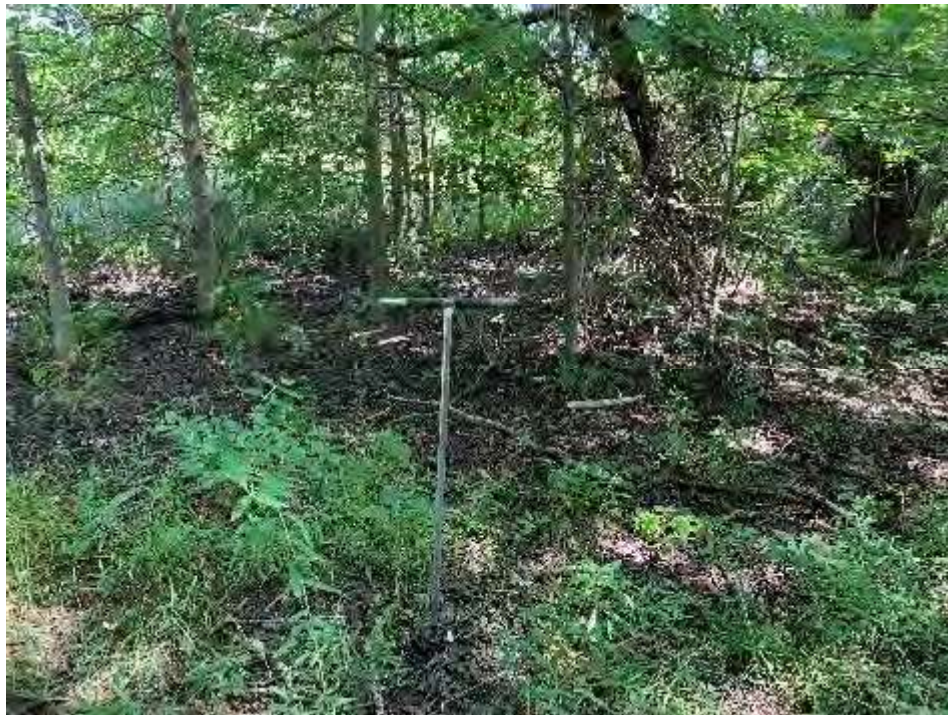
DPW7. Forested Wetland B was dominated by black willow (*Salix nigra*) and pin oak (*Quercus palustris*), with teal lovegrass (*Eragrostis hypnoides*) and green ash (*Fraxinus pennsylvanica*) in the understory. Primary hydrology indicators included a sparsely vegetated concave surface and oxidized rhizospheres on living roots. Depleted below dark surface and redox dark surface were the hydric soil indicators. Photo taken July 28, 2020.

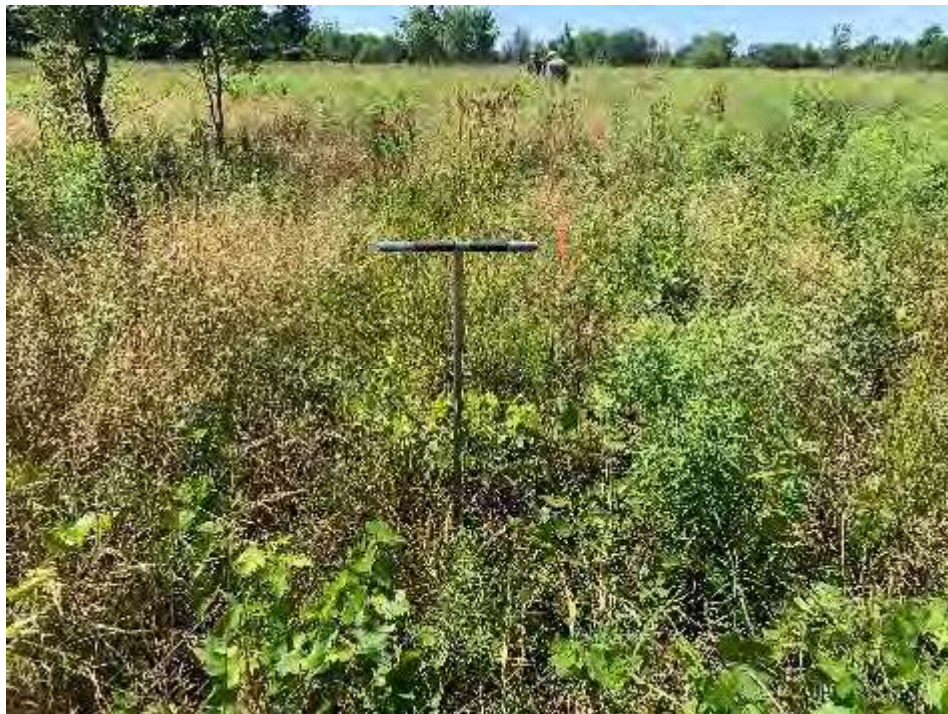
DPW8. This portion of emergent Wetland G was dominated by rough bentgrass (*Agrostis scabra*), meadow foxtail (*Alopecurus pratensis*), and common goldentop (*Euthamia graminifolia*). The primary

hydrology indicator was oxidized rhizospheres on living roots. A depleted matrix was the hydric soil indicator. Photo taken August 6, 2020.

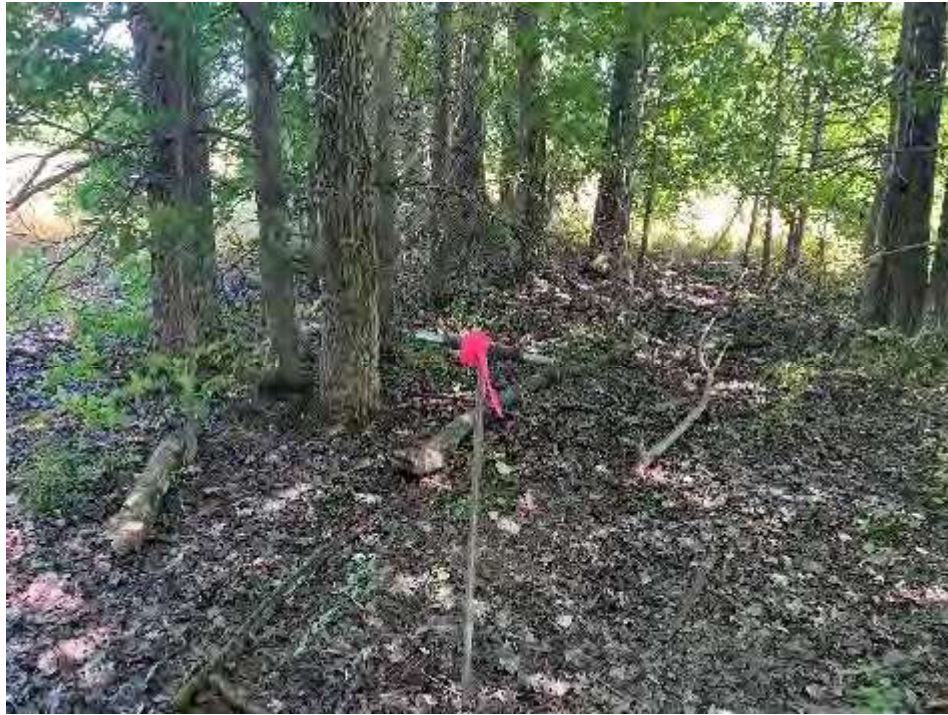
DPW9. Forested Wetland F was dominated by pin oak (*Quercus palustris*) and eastern cottonwood (*Populus deltoides*), with green ash (*Fraxinus pennsylvanica*) in the understory. The primary hydrology indicator was oxidized rhizospheres on living roots. Redox dark surface was the hydric soil indicator. Photo taken August 6, 2020.

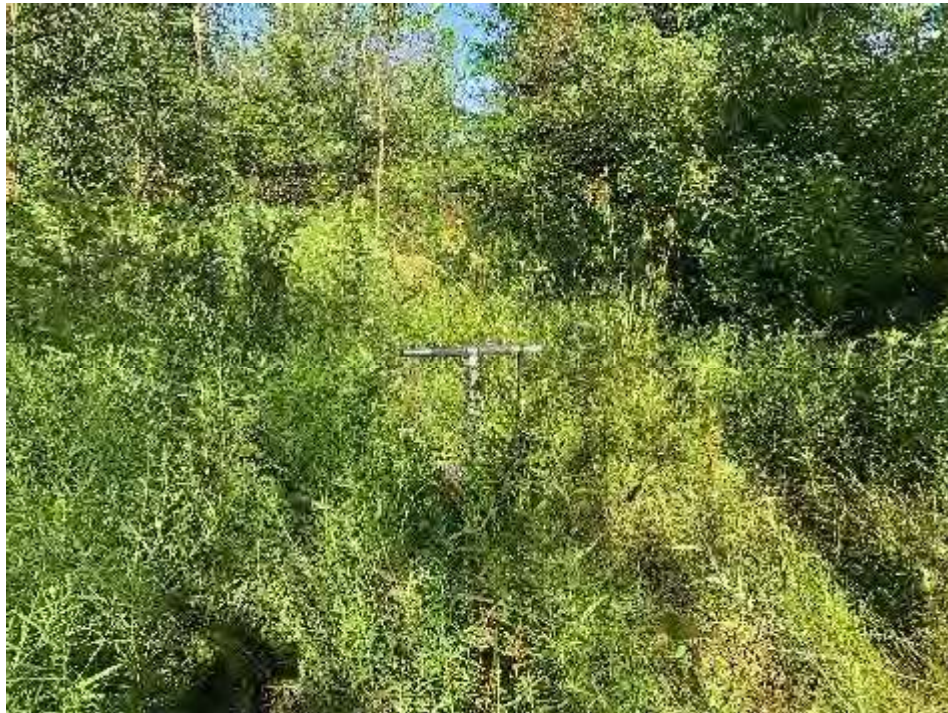
DPW10. This portion of forested Wetland H was dominated by green ash (*Fraxinus pennsylvanica*), with gray dogwood (*Cornus racemosa*), fox sedge (*Carex vulpinoidea*), and common goldentop (*Euthamia graminifolia*) in the understory. The primary hydrology indicator was oxidized rhizospheres on living roots. A depleted matrix was the hydric soil indicator. Photo taken August 6, 2020.
